POTOMAC RIVER BASIN

Name Of Dam: LAKE JACKSON DAM

Inventory Number: VA. 15306

## PHASE I INSPECTION REPORT NATIONAL DAM SAFETY PROGRAM

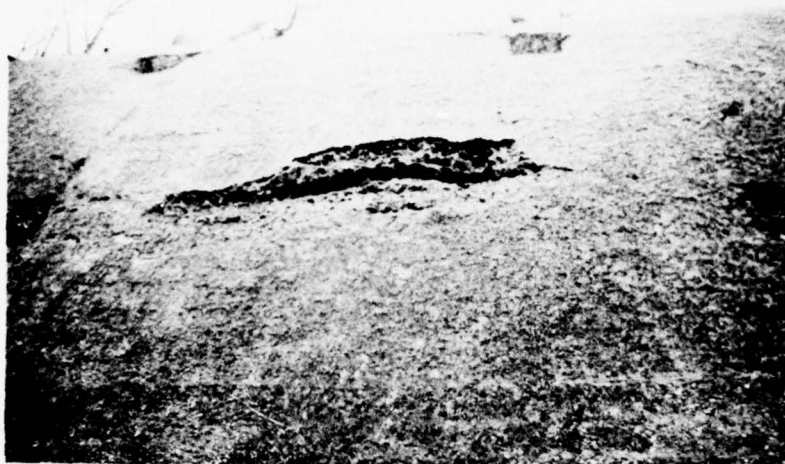
LAKE JACKSON DAM - SPALL ON  
SURFACE OF SPILLWAY

The tainter gate was opened to lower the lake level below the crest of the dam. This action was requested by the Corps of Engineers to expose the face of the spillway for inspection. A few cracks, severe weathering and deterioration of concrete were visible on the exposed spillway. However, the face was covered by a green algae-type growth which made thorough observations difficult.

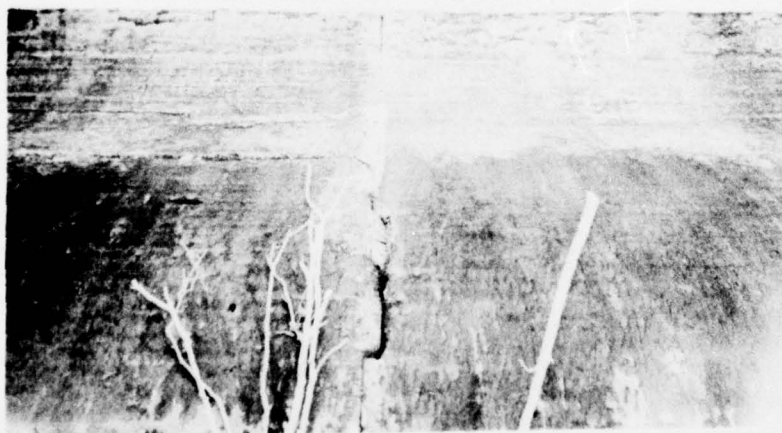
PLATE 4

LAKE JACKSON DAM - SPALLING  
AT CONSTRUCTION JOINT

The catwalk above the dam had much concrete deterioration along its top surface. This deterioration appeared to be the result of freeze-thaw action.

7.2.3 Repair weathered concrete all along the catwalk and powerhouse by applying a topping or grout finish.

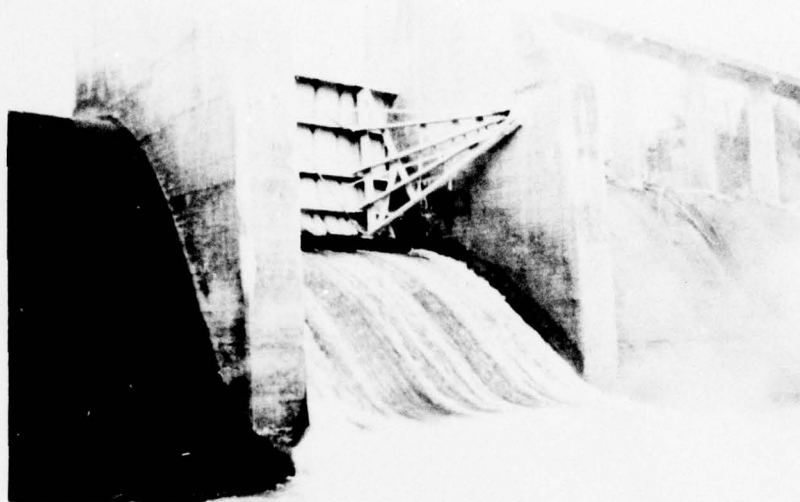
3.1 Findings: Information observed in the field is outlined in Appendix D. Overall, the concrete dam had severe signs of weathering and deterioration. Evidence of seepage along the right abutment contact did not appear to be critical, but determination could not be made on a visual inspection. Upon closure, the tainter gate did not seat firmly against the bottom sill to stop the flow of water.

LAKE JACKSON DAM - TAINTER GATE

Over the top of the tainter gate is a machinery room. An electrical winch opens the gate. The opening height is graduated in revolutions. The tainter gate appeared to be in good condition. However, when it was closed at the end of the inspection, a large flow of water passed under the gate. A county representative remarked that the gate did not seal right away.

7.2.2 Install a new bottom sill and seal for the tainter gate.

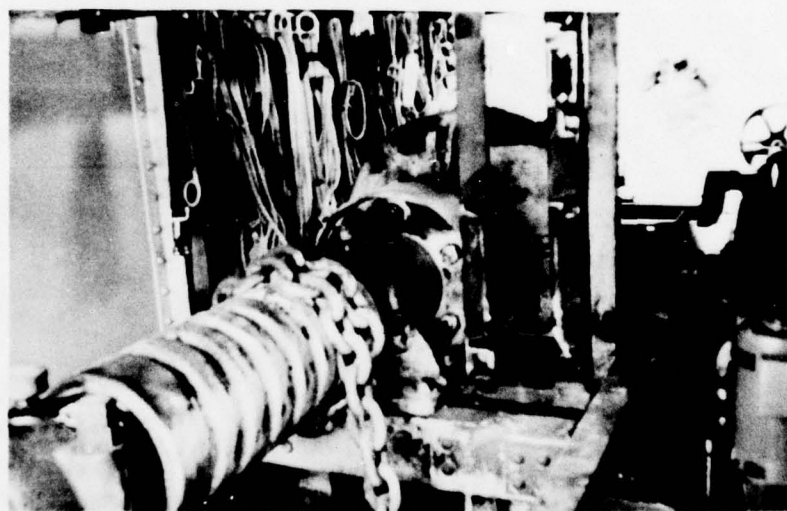
PLATE 5

4.1 Procedures and Maintenance: Most operating procedures are done as the need arises. Maintenance is performed monthly by county personnel. Large amounts of water-borne debris are caught by the catwalk piers. Debris removal is accomplished irregularly. The tainter gate lifting machinery is kept in good condition. Operating and maintenance manuals and records are not kept.

LAKE JACKSON DAM - TAINTER GATE  
HOIST EQUIPMENT
